SA-021/23 - Qi WIRELESS CHARGER SYMPTOM TROUBLESHOOTING

SA NUMBER: SA-021/23

APPLICABLE MODEL(S)/VINS

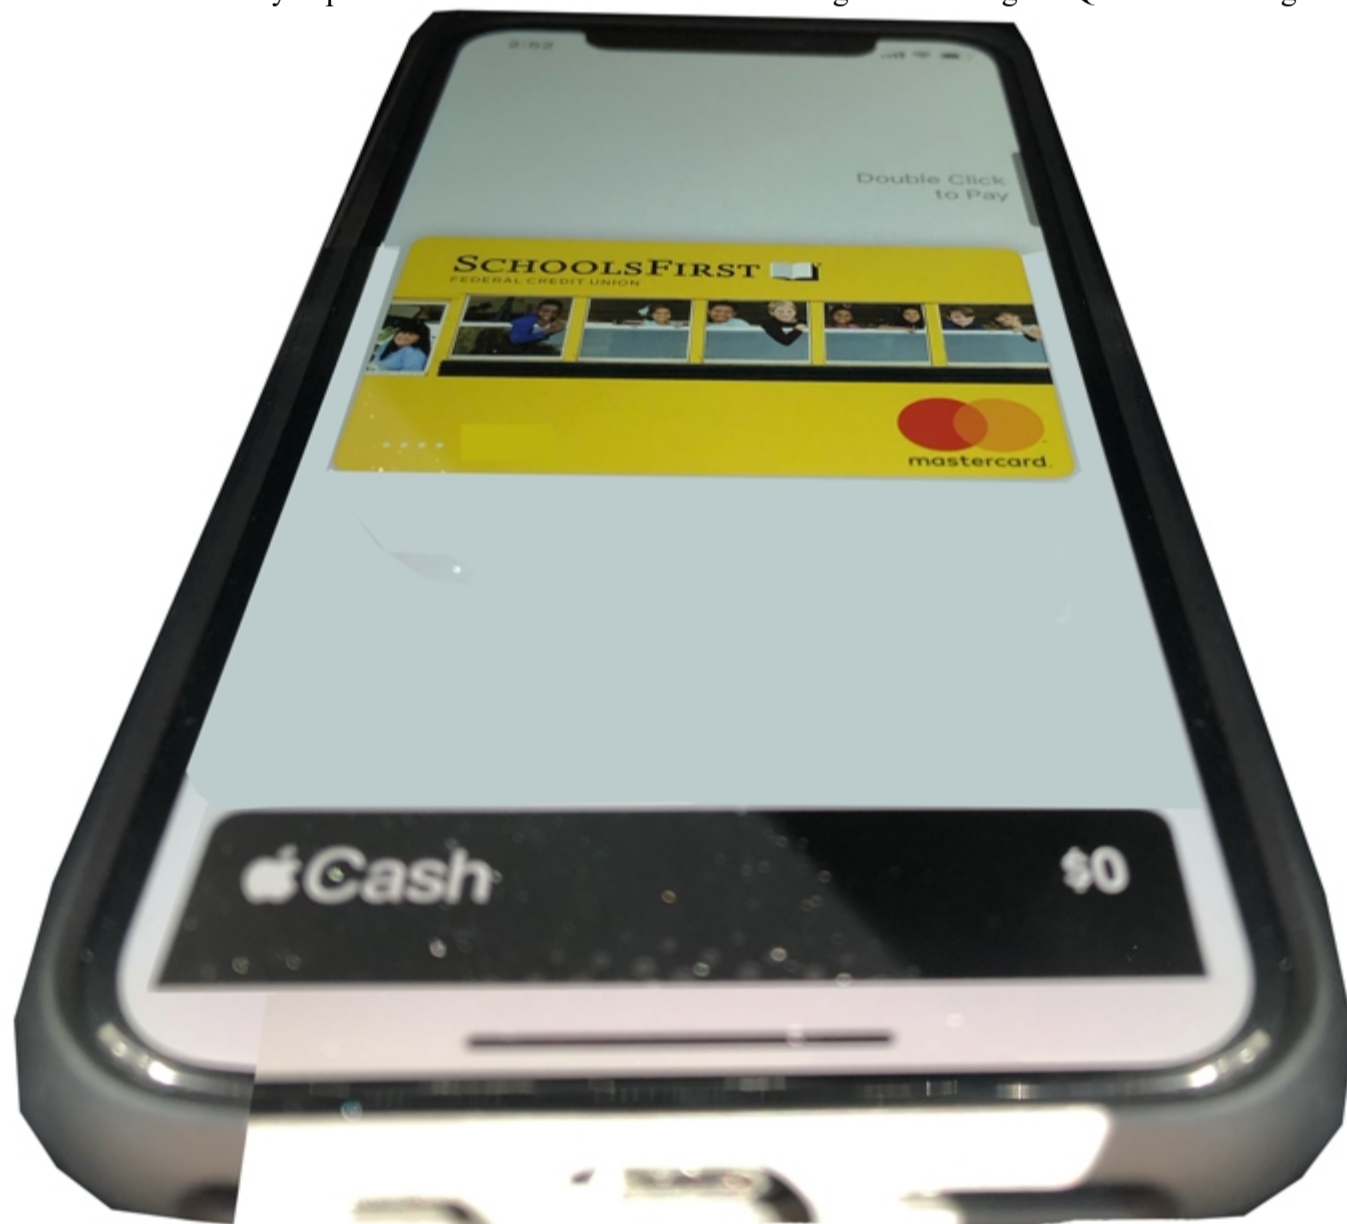
2. Some customers may experience an iPhone "Cash" Error Message when using the Qi wireless charger.

No vehicle repair is necessary. This is an iPhone OS software error.
