## TECH BULLETIN

Bulletin: **NS020\_12** Issued: **4/05/2012** Revised: **16/09/2013** Page: 1 of 5

Title: **Peeling of the Door Trim Arm Rest Surface**

Model(s): **CX-7 (ER10\*2)** Category: **Body**

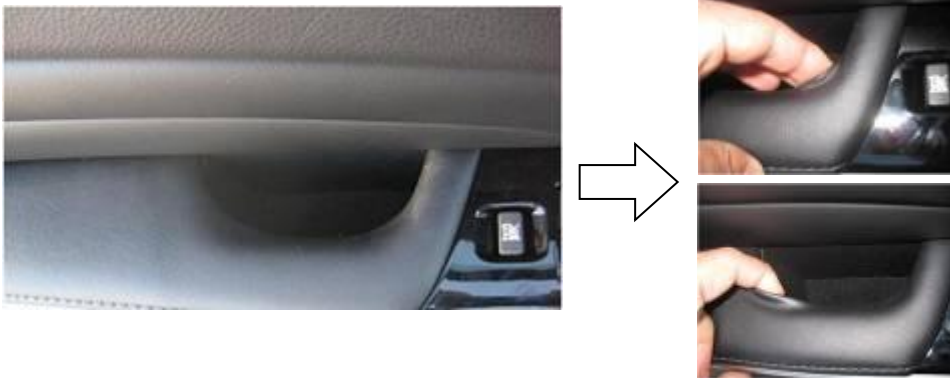
The surface of the door trim arm rest may peel off and give a poor appearance.

Due to inappropriate adhesion, the arm rest surface may peel when it is handled over time.

If you encounter a customer complaint on this concern, replace the damaged arm rest with a modified one according to the following procedure.
