09 002/05 2003 2004 Mazda6 Front Turn Signals Inoperative

TSB: 09-002/05

2003 - 2004 MAZDA6 - FRONT TURN SIGNALS INOPERATIVE

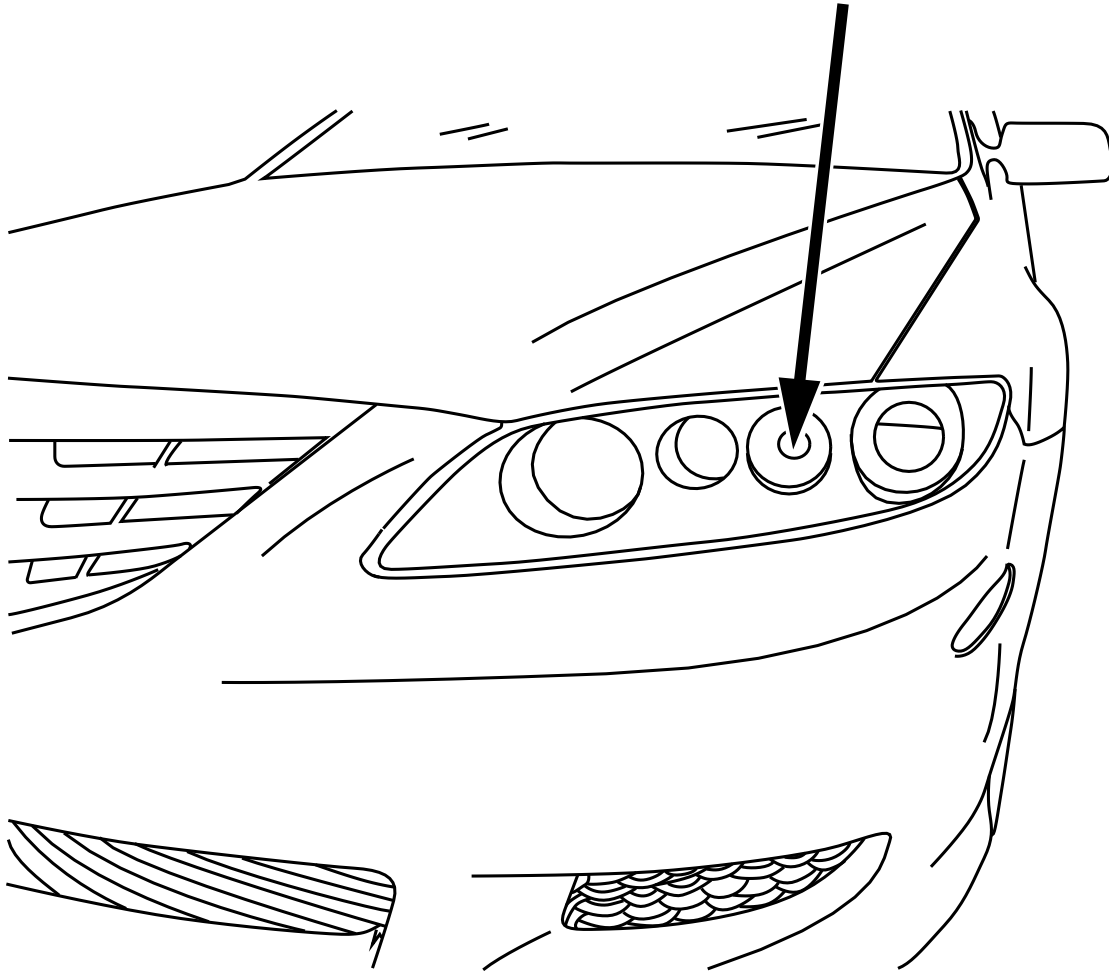
1426a

TURN SIGNAL LIGHT

1. Verify customer concern.

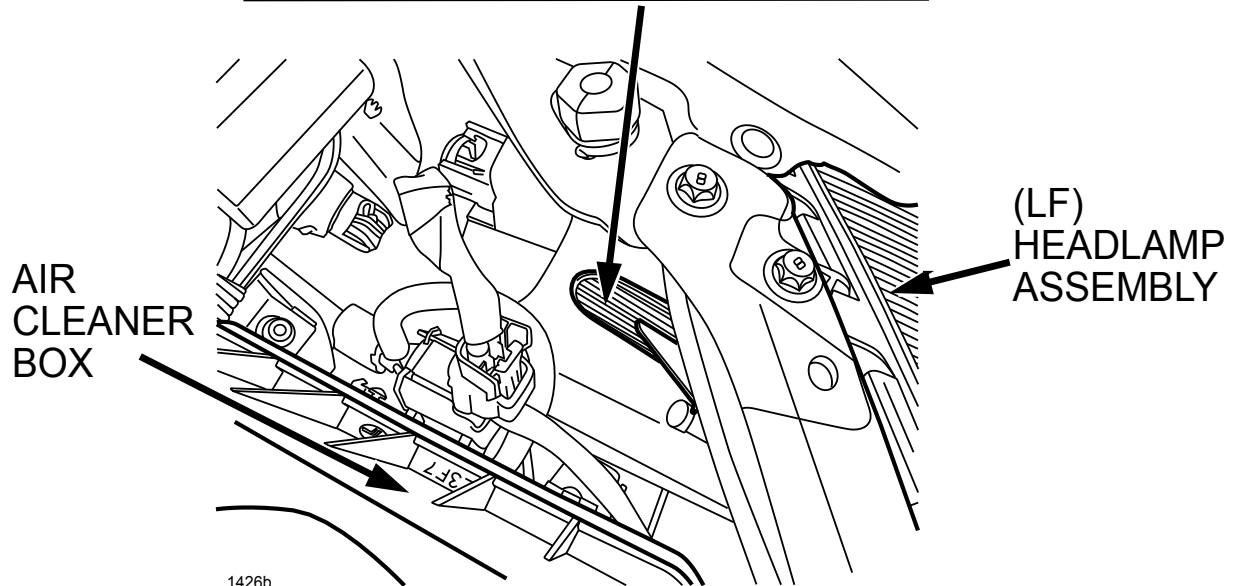
1426b

LF TURN SIGNAL BULB SOCKET TAB

2. Locate large plastic tab on turn signal bulb socket.

3. Grasp plastic tab and rotate 1/4 turn counterclockwise.

4. Pull turn signal bulb socket assembly outward and remove from headlamp assembly.

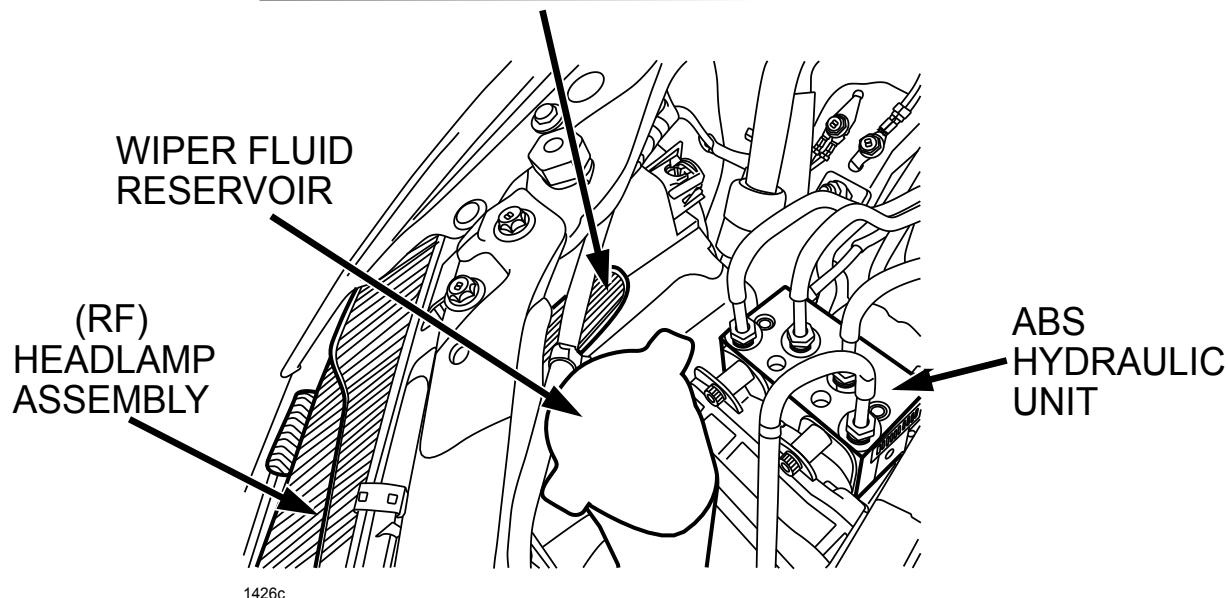
1426c

RF TURN SIGNAL BULB SOCKET TAB

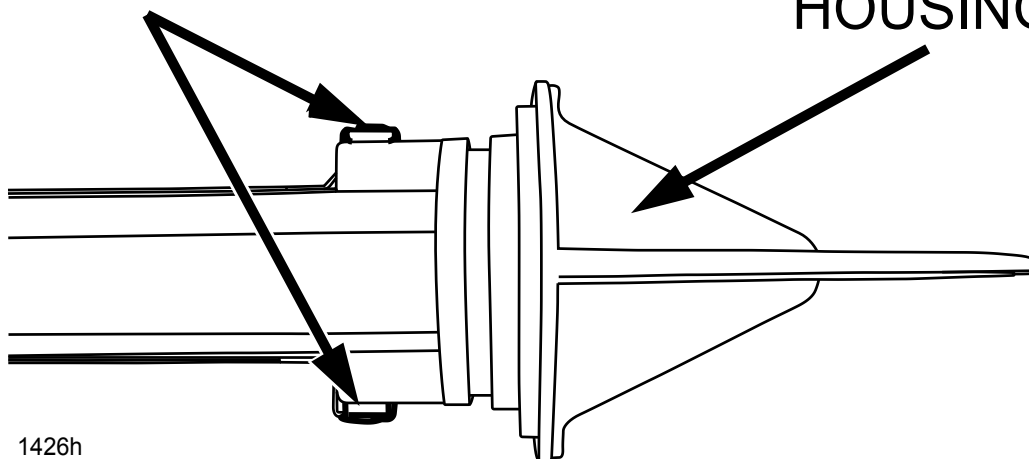
1426h

NOTE: A silicon spacer will be inserted under both electrical terminals on turn signal bulb socket housing to keep tension on terminals.

ELECTRICAL TERMINAL

BULB SOCKET HOUSING

5. Obtain two (2) 1/8" x 5/16" silicon spacers supplied in the kit.
