# Service Information

Category <b>T</b>	<b>Repair Guidance</b>	Ref. No. <b>R018/18REV</b>	Page 1 of 3
Coverage <input type="checkbox"/> Distributor only <input checked="" type="checkbox"/> Please inform your dealers		Date Issued <b>March 20, 2018</b>	
Please convey this information to your <input type="checkbox"/> Director <input checked="" type="checkbox"/> General Manager <input checked="" type="checkbox"/> Warranty Dept. <input checked="" type="checkbox"/> Parts Dept. <input checked="" type="checkbox"/> Training Dept. <input checked="" type="checkbox"/> Field Rep.		Date Revised <b>June 08, 2018</b>	
Applicable Model  Mazda2(DJ) , CX-3 (DK) and MX-5(ND)	Applicable Countries and/or Vehicle Specifications  Worldwide

## **Subject: Spider cracking on Center Display**

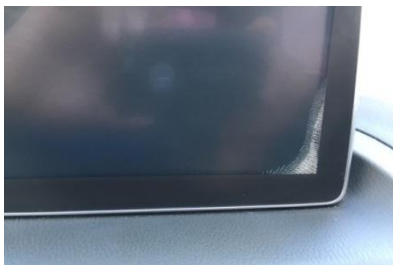
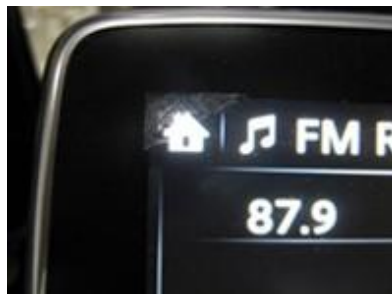
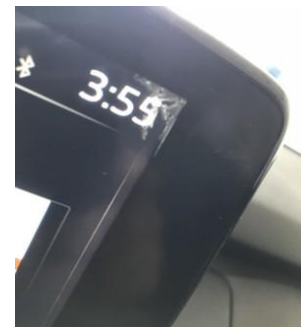
Some customers may complain about poor appearance (Spider cracking) on the center display. Since it is internal damage of the display, there is no dent or crack on the surface.

Lack of glue between the touch screen and its layer.

1. Check if the screen is internally damaged (no external impact).  
IF YES, go to the next step.  
IF NO, this Service Information does not apply.
2. Replace the center display with a modified one according to the workshop manual.  
See the workshop manual" CENTER DISPLAY REMOVAL/INSTALLATION".
3. See the label at the bottom of the center display to check if production date is in or after July 7/2016.  
IF YES, this Service Information does not apply. Submit a warranty claim according to the normal warranty procedure.  
IF NO, submit a warranty claim according to the warranty information of this Service Information.

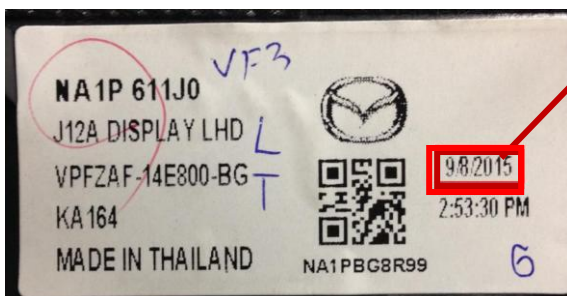
Month/Date/Year.
