SSPD8 - Check Engine Light ON with DTC P0126:00

WARRANTY EXTENSION

**REPAIR PROCEDURE & PARTS AND WARRANTY INFORMATION
WARRANTY EXTENSION SSPD8**

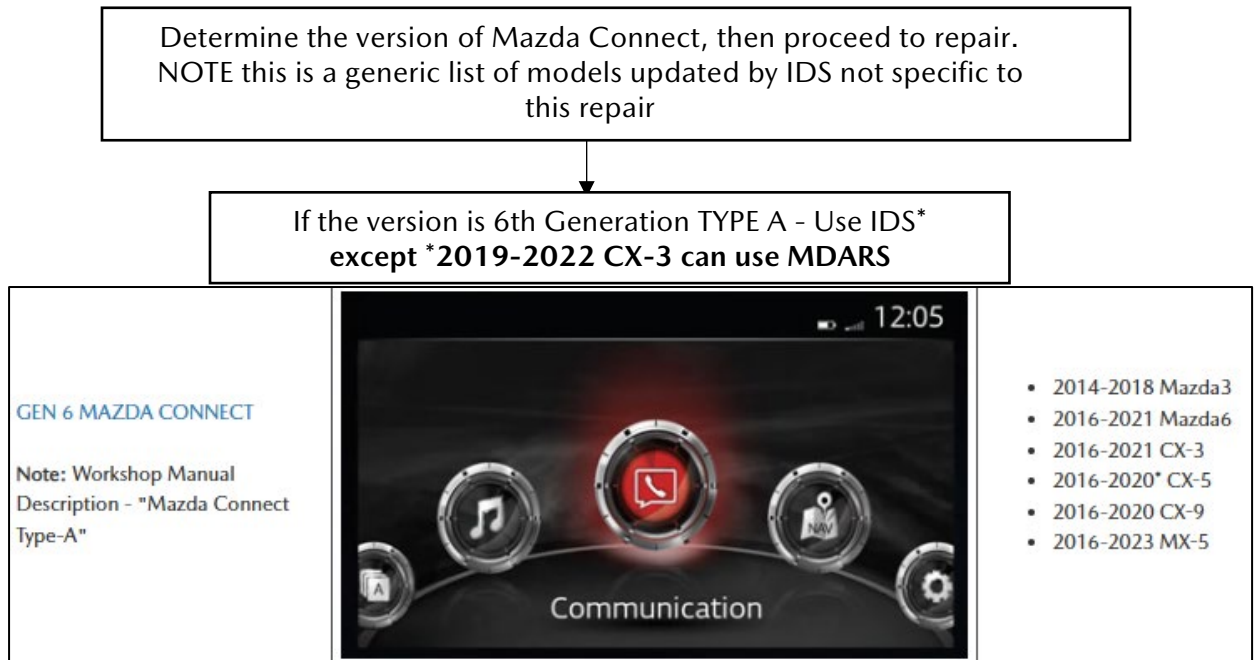
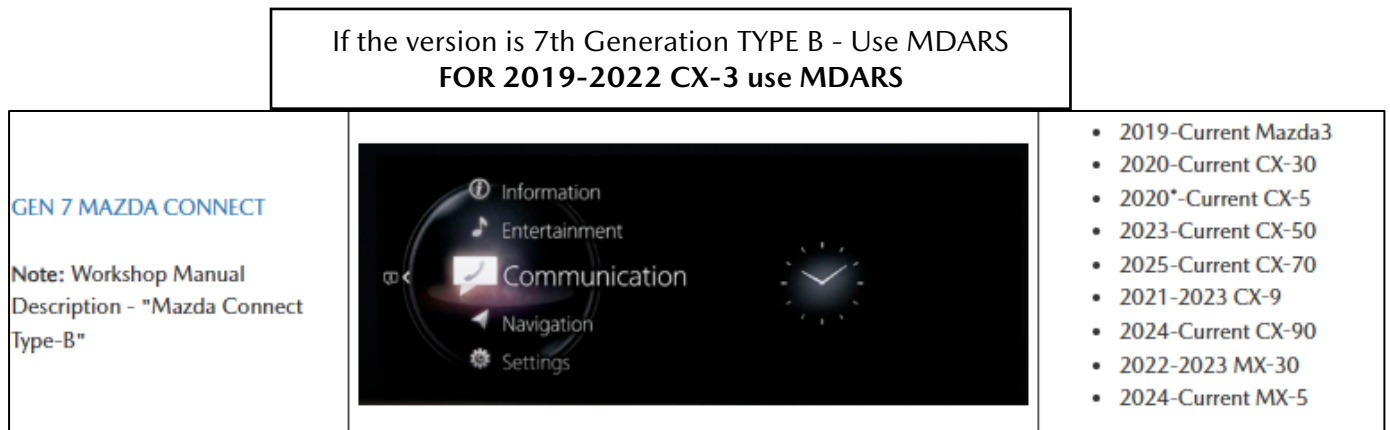
Section A: Flow Chart: **NOTE: This Flow Chart needs to be followed strictly.**

REPAIR PROCEDURE – FLOW CHART - The thermostat repair information has been removed.
PLEASE FOLLOW THE FLOW CHART BELOW BEFORE PERFORMING THE REPAIR.

The dummy plug and PCM update repair procedure are required as of December 8, 2025. The TSB has been updated to repair with the dummy plug and PCM update here: [Technical Service Bulletin \(TSB\) No. 01-003/25](#).
