Technical Service Bulletin

Subject: SBS/SCBS WARNING LIGHT ON WITH DTC U0420:68	Bulletin No.: 15-003/20
	Last Issued: 10/02/2020

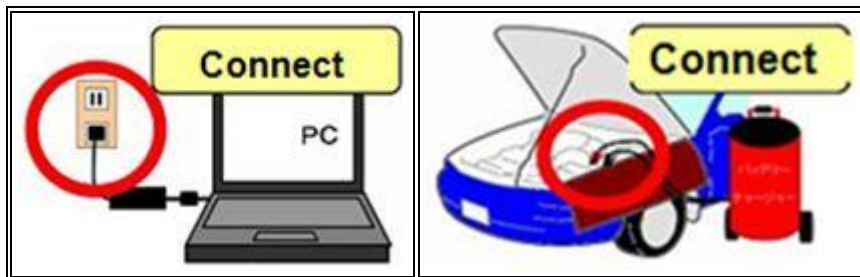
- Make sure that the following connections are firmly connected:
 - Between the vehicle-side connector and the DLC cable
 - Between the PC-side connector and USB port of PC
- DO NOT touch the VCM and DLC cable to prevent noise and a poor connection.
- Connect the AC adapter to the PC in order to stabilize voltage fluctuation during reprogramming. DO NOT use the vehicle battery outlet as a power source for the PC.

- During reprogramming, connect a battery charger to the vehicle with the charge current maintained within 10 to 15A to stabilize voltage fluctuation.

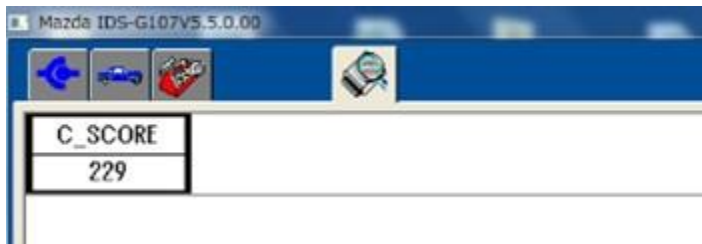
The C_SCORE indicates the FSC temperature. As the temperature rises, the value of C_SCORE decreases, therefore "C_SCORE" must be **174 or higher** to perform the FSC reprogramming.
