If an older version of the CMU software is being used, the CarPlay/Android Auto-compatible USB hub may not be recognized.

[Sold separately] The following part is also necessary for installation. HUB unit (Part No. TK78 66 9U0**)

1. INSTALLATION VIEW

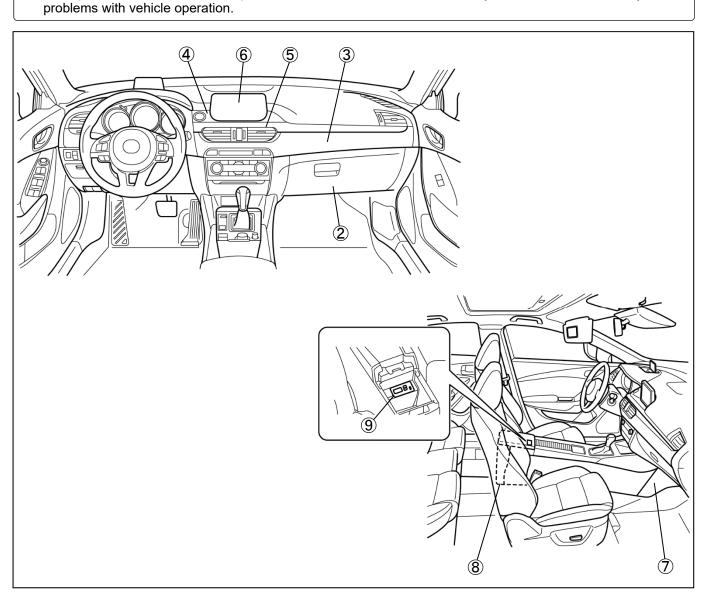
2. VEHICLE PART REMOVAL

- 1 Negative battery cable disconnection
- ② Glove compartment
- **③ Decoration panel**
- (4) Audio panel
- **5** Center panel
- 6 Center display
- \bigcirc Passenger-side side wall
- **8** Console panel
- (9) Console up

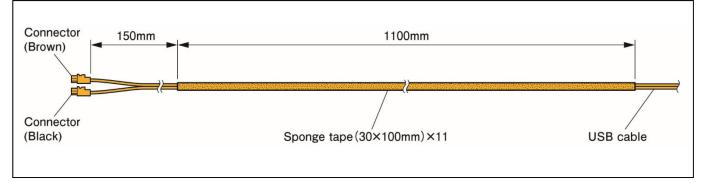
1. Wind sponge tape (100 mm x 30 mm) around the USB cable.

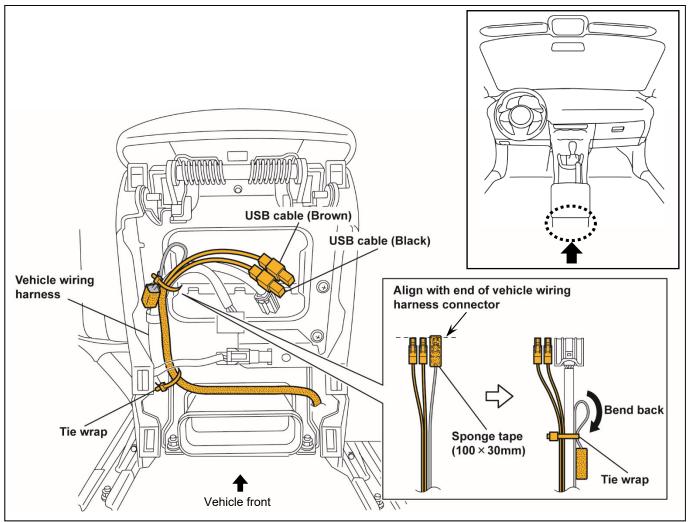
4. CABLE ROUTING

- To prevent noise, wrap the disconnected vehicle wiring harness connector with a piece of sponge tape (100 x 30 mm).
- 2. Align the ends of the vehicle wiring harness connector and the USB cable connector.
- 3. Bend back the vehicle wiring harness connector, and then use a tie wrap to secure the vehicle wiring harness together with the USB cable.
- 4. Secure the USB cable to the vehicle wiring harness with a tie wrap.

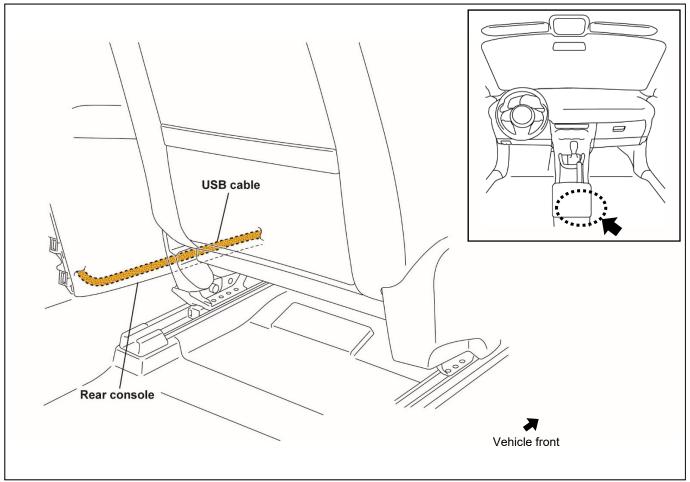
5. Slide the seat forward and push the USB cable into the rear console.

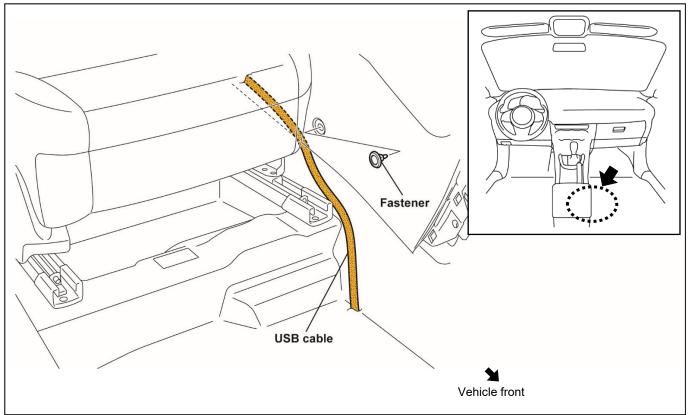
6. Slide the seat back and then remove the fastener.

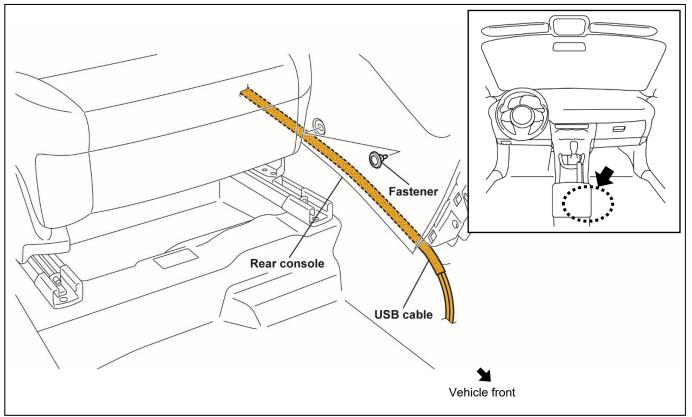
7. Push the USB cable into the rear console and then install the fastener.

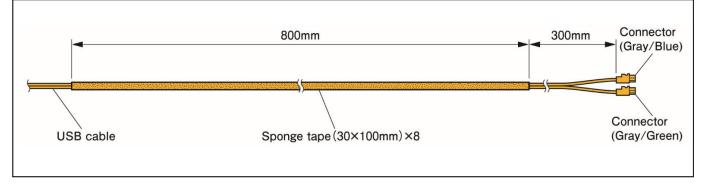
8. Wind sponge tape (100 mm x 30 mm) around the USB cable.

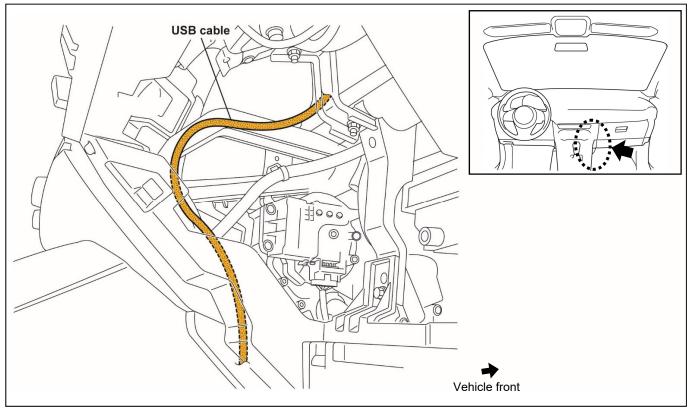
9. Route the USB cable to the underside of the center display.

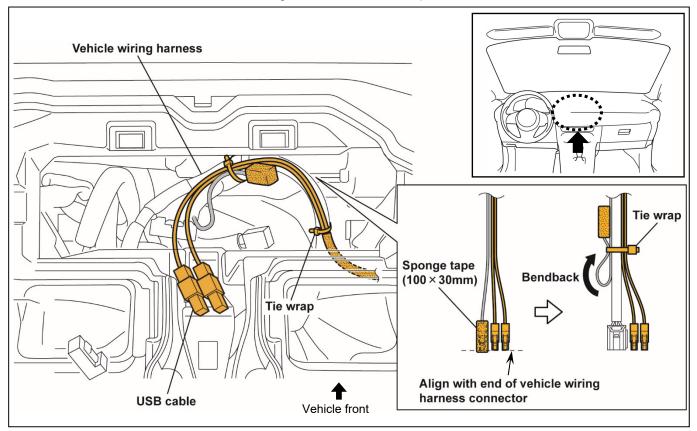
- 10. To prevent noise, wrap the disconnected vehicle wiring harness connector with a piece of sponge tape (100 x 30 mm).
- 11. Align the ends of the vehicle wiring harness connector and the USB cable connector.
- 12. Bend back the vehicle wiring harness connector, and then use a tie wrap to secure the vehicle wiring harness together with the USB cable.
- 13. Secure the USB cable to the vehicle wiring harness with a tie wrap.

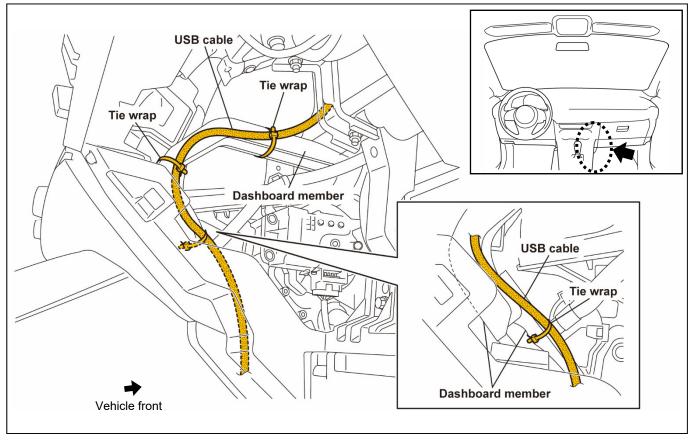
14. Secure the USB cable to the dashboard member with tie wraps.

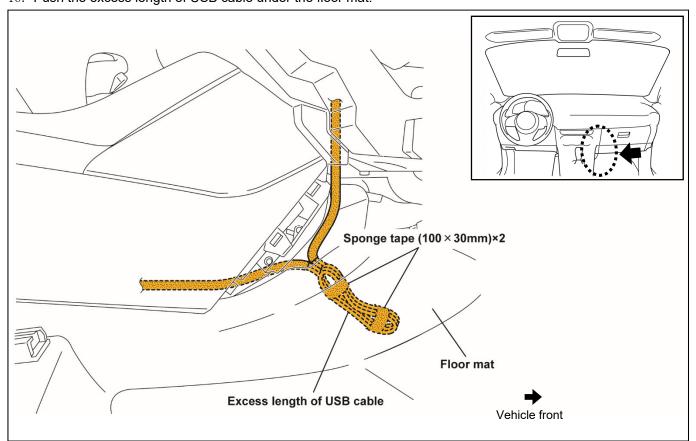
15. Bind the excess length of USB cable together and secure it with sponge tapes (100 x 30 mm).16. Push the excess length of USB cable under the floor mat.

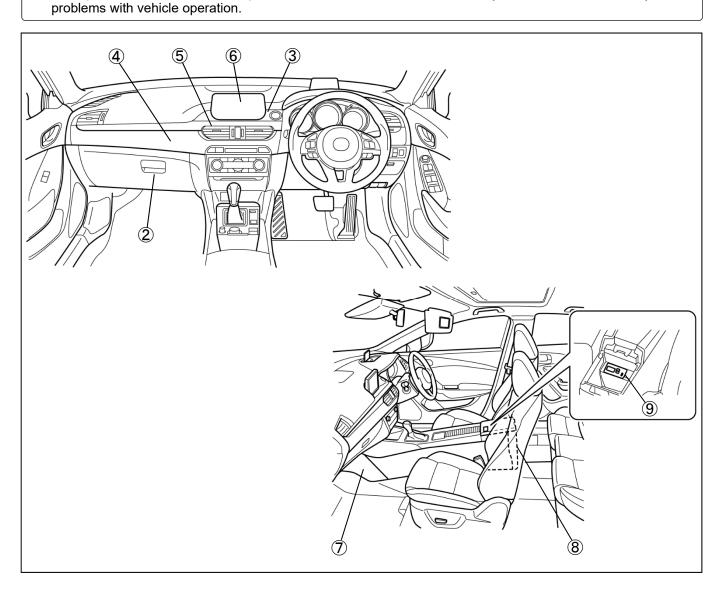
2. VEHICLE PART REMOVAL

- ① Negative battery cable disconnection
- ② Glove compartment
- **③ Decoration panel**
- (4) Audio panel
- **(5)** Center panel
- 6 Center display
- \bigcirc Passenger-side side wall
- **(8)** Console panel
- (9) Console up

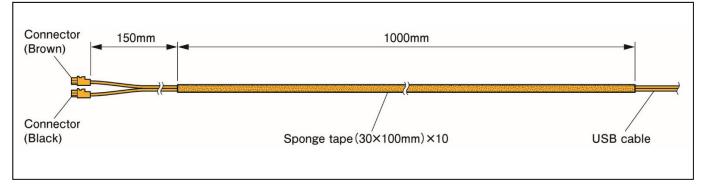
1. Wind sponge tape (100 mm x 30 mm) around the USB cable.

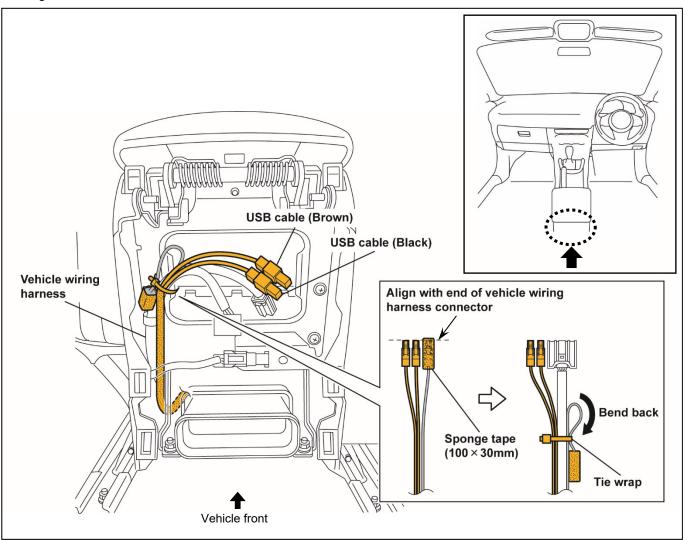
4. CABLE ROUTING

- To prevent noise, wrap the disconnected vehicle wiring harness connector with a piece of sponge tape (100 x 30 mm).
- 2. Align the ends of the vehicle wiring harness connector and the USB cable connector.
- 3. Bend back the vehicle wiring harness connector, and then use a tie wrap to secure the vehicle wiring harness together with the USB cable.

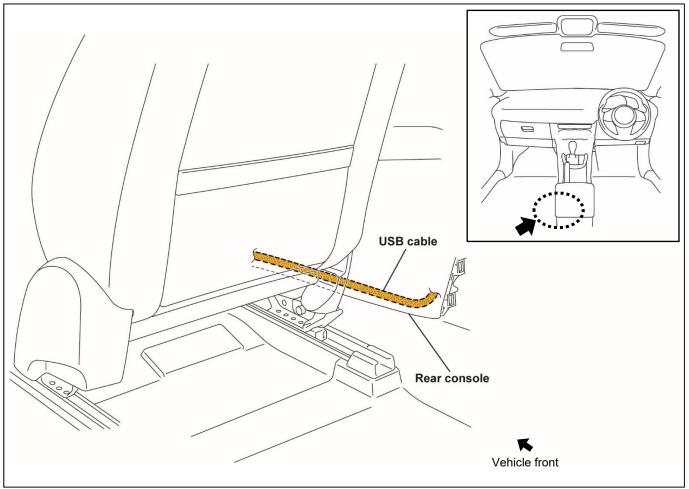
4. Slide the seat forward and push the USB cable into the rear console.

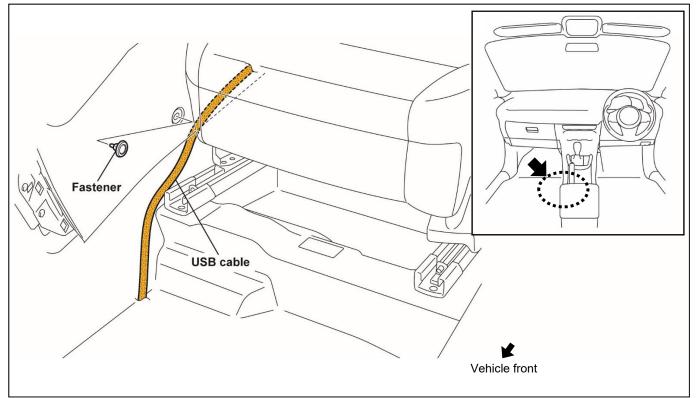
5. Slide the seat back and then remove the fastener.

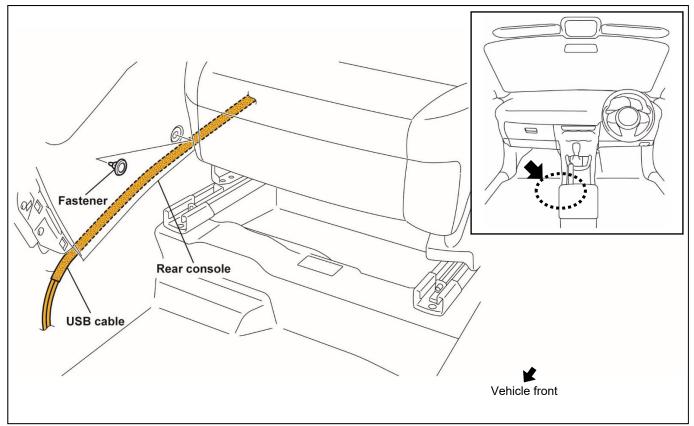
6. Push the USB cable into the rear console and then install the fastener.

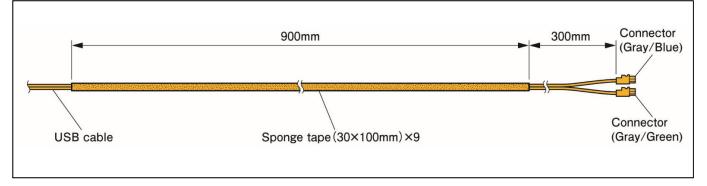
7. Wind sponge tape (100 mm x 30 mm) around the USB cable.

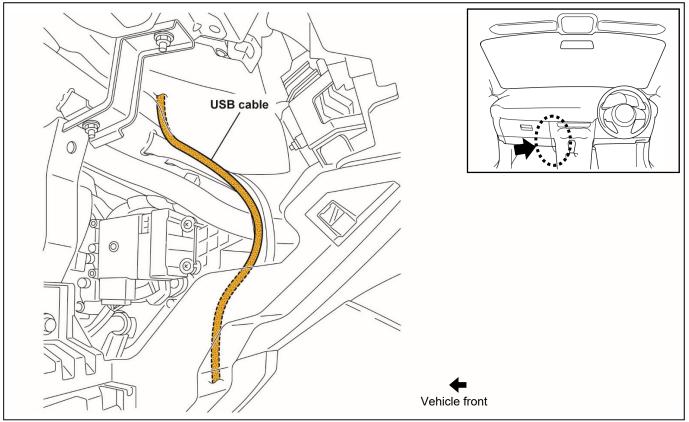
8. Route the USB cable to the underside of the center display.

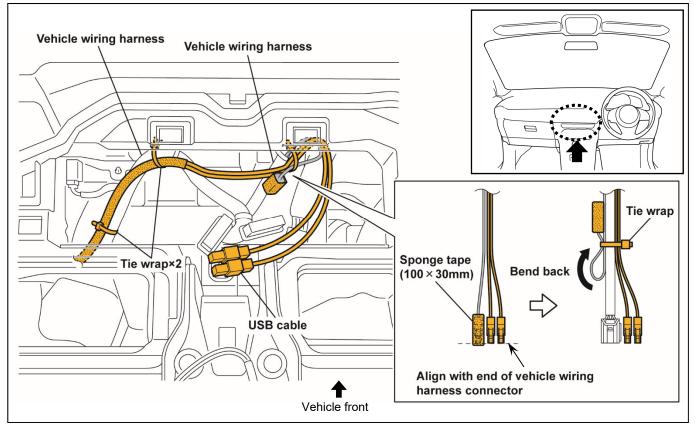
- 9. To prevent noise, wrap the disconnected vehicle wiring harness connector with a piece of sponge tape (100 x 30 mm).
- 10. Align the ends of the vehicle wiring harness connector and the USB cable connector.
- 11. Bend back the vehicle wiring harness connector, and then use a tie wrap to secure the vehicle wiring harness together with the USB cable.
- 12. Secure the USB cable to the vehicle wiring harness with a tie wrap.

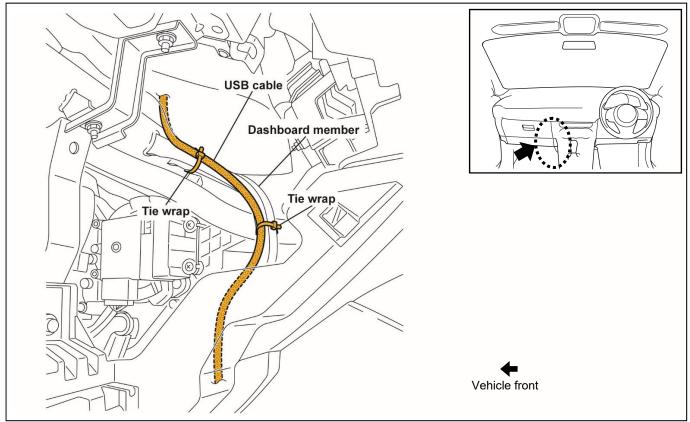
13. Secure the USB cable to the dashboard member with tie wraps.

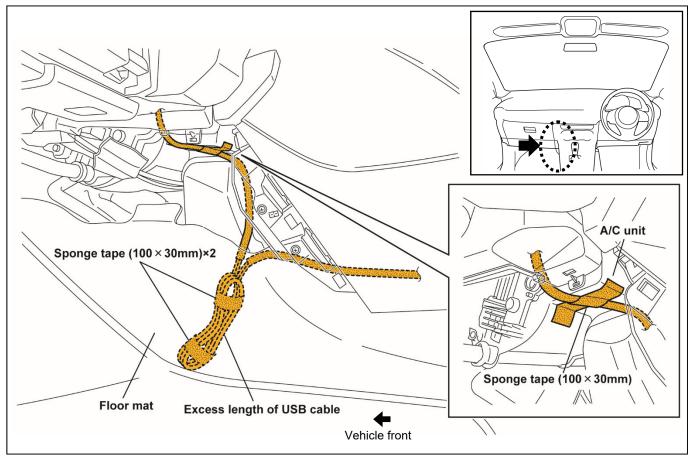
- 14. Secure the USB cable to the A/C unit with sponge tape (100 x 30 mm).
- 15. Bind the excess length of USB cable together and secure it with sponge tapes (100 x 30 mm).
- 16. Push the excess length of USB cable under the floor mat.
